SHUTTLE MEADOW RESERVOIR DAM CT 00162

PHASE I INSPECTION REPORT NATIONAL DAM INSPECTION PROGRAM

MARCH 1979

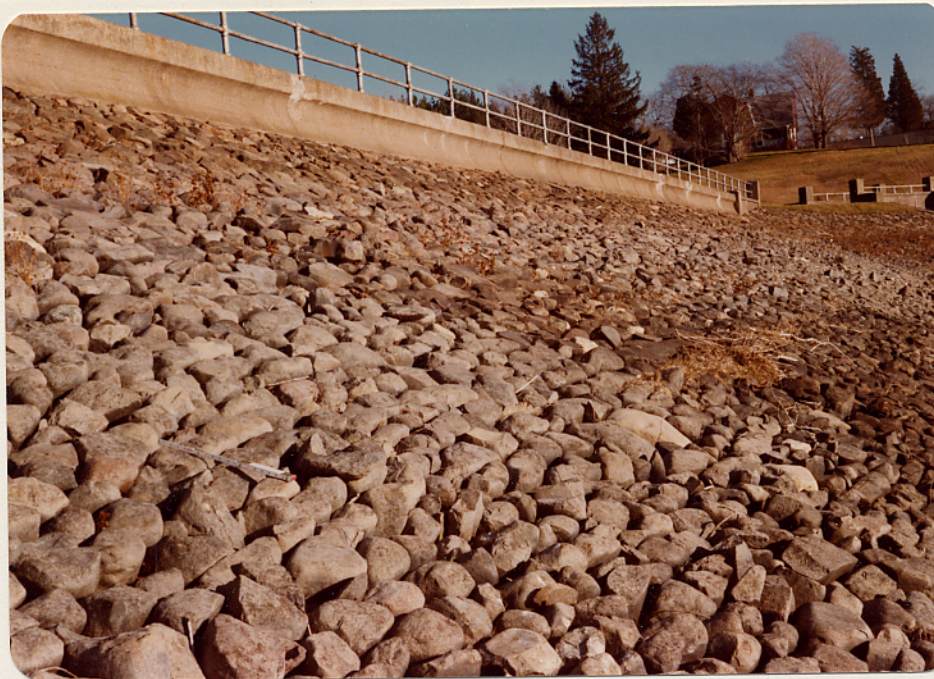
Upstream Slope - The upstream slope is covered with hand placed riprap and is generally in very good condition as shown in Photo 1. There are two small areas near the left abutment and near the top of the slope where riprap is missing.

PHOTO 1 - Hand placed riprap on upstream face below concrete wave wall on crest of dam.

4. The cutting of grass on the crest and downstream slope should be continued as part of the routine dam maintenance.
5. Riprap missing on the upstream slope should be replaced.

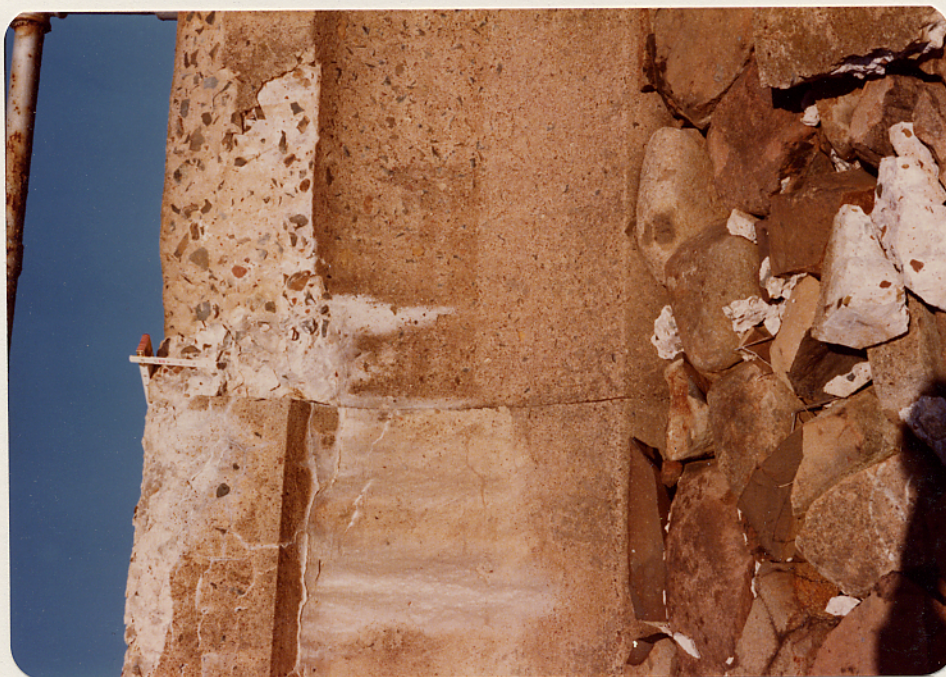
Crest - The crest is grass covered and has a concrete coping wall along the upstream edge as shown in Photo 1. No misalignment of the crest was observed as judged by the coping wall. Small depressions (probably tire tracks) on the crest due to trespassing vehicles were observed. Spalling of the concrete coping wall has occurred as can be seen in Photo 2.

PHOTO 2 - Spalling of upstream face of concrete wave wall. Note fallen chunks of concrete.

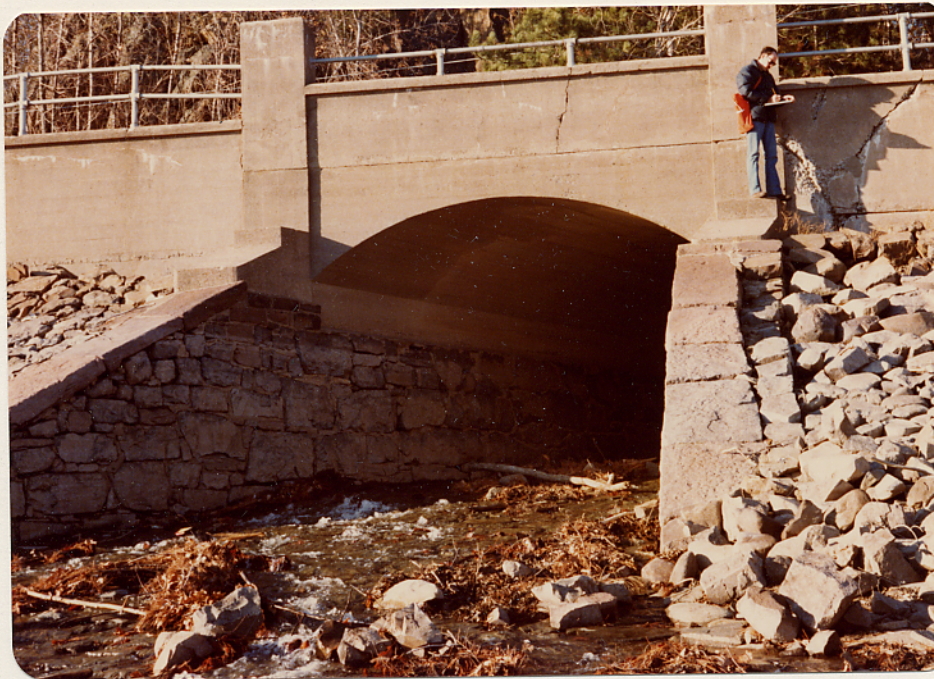
c. Appurtenant Structures - There are several cracks in a concrete wall supporting the roadway passing over the left diversion canal inlet to the reservoir. The most severe cracking is to the right of the canal inlet as shown in Photos 3 and 4. The cracks have offset varying amounts, the largest amount being about 1.2 inches. The roadway pavement adjacent to the cracked area is in good condition.

PHOTO 3 - Left diversion inlet. Note cracks in roadway bridge abutment.

1. Wet areas at the downstream toe of the dam should be monitored periodically for increased seepage. The water flow from the observation well should also be monitored.
2. Cracking of the concrete wall supporting the roadway should be repaired. The displacement should be monitored periodically for any worsening of the condition.
3. The small amount of stones and mortar missing or deteriorated in the spillway channel sidewalls should be replaced or repaired.
4. Spalling of the coping wall will increase if not repaired.
5. The small depressions on the crest of the dam are not a problem, but should be monitored for worsening of the condition.
6. The valves to the low level outlet pipes are located on the downstream side of the dam which means that even in the closed position, the pipe running through the dam is full of water under pressure.

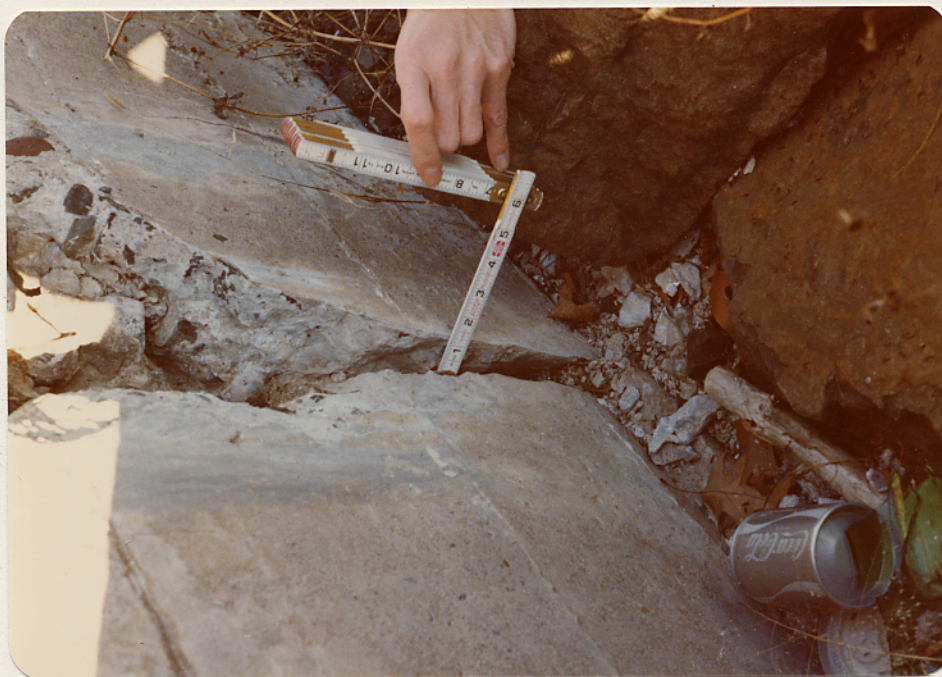
PHOTO 4 - Close-up of crack in bridge showing horizontal displacement.

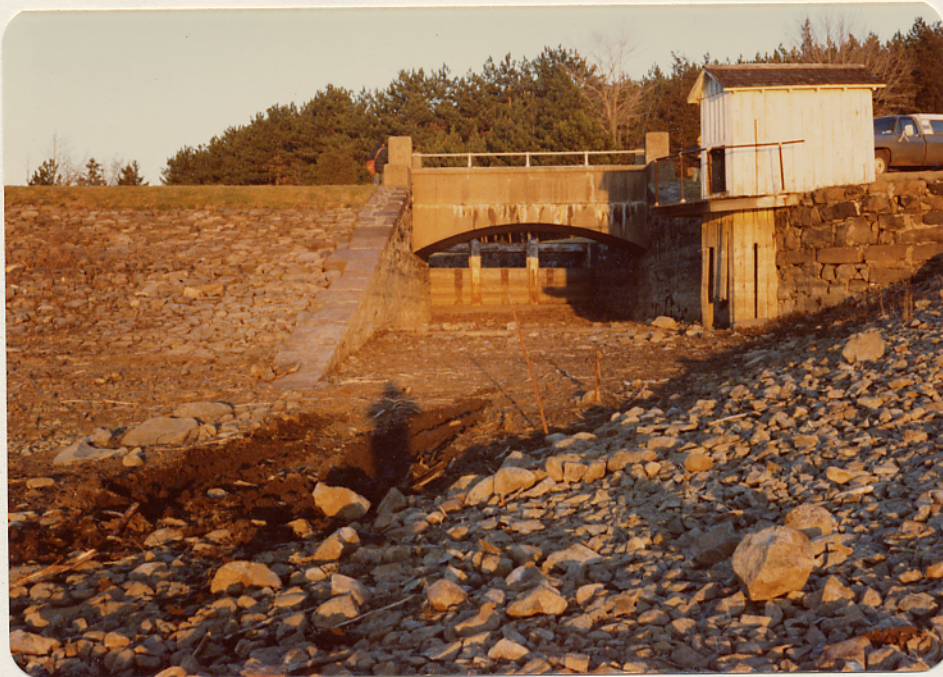
Spillway - The walls of the spillway approach channel and discharge channel are of stone masonry construction and are in good condition (Photos 5 and 6). There are a few stones and some mortar dislodged from the face of the walls. Several large pieces of cut stone are resting on the channel floor. They are designed possibly to dissipate the effects of water striking the channel walls. The stone blocks are extraneous to the spillway, i.e., they were not dislodged from or originally part of the spillway or channel, and hence do not present a problem, other than impeding flow in the spillway channel. The floor of the channels are of stone with some grass growing through. The wooden stoplogs in the spillway channel appear very sound and in good condition.

PHOTO 5 - Spillway approach channel with stoplogs.

It is recommended that the owner remove the stoplogs immediately upon receipt of this report. It is also recommended that further studies be undertaken to perform a more refined hydraulic/hydrologic study to determine the best way to increase the ability of the spillway to pass a greater percentage of the Test Flood.

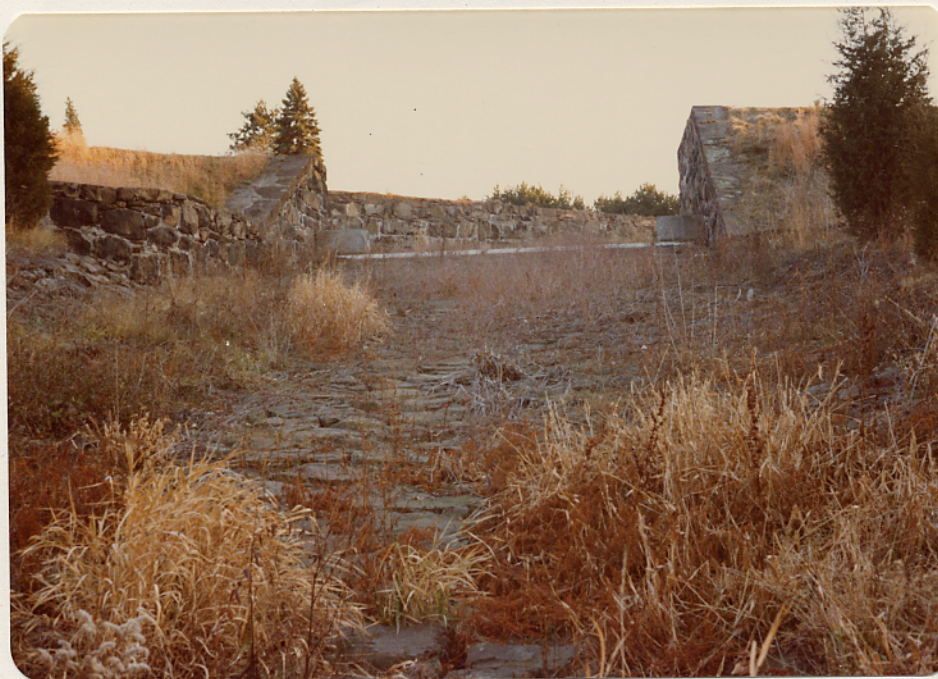
PHOTO 6 - View of spillway discharge channel from downstream.
Note stone lined channel bottom.

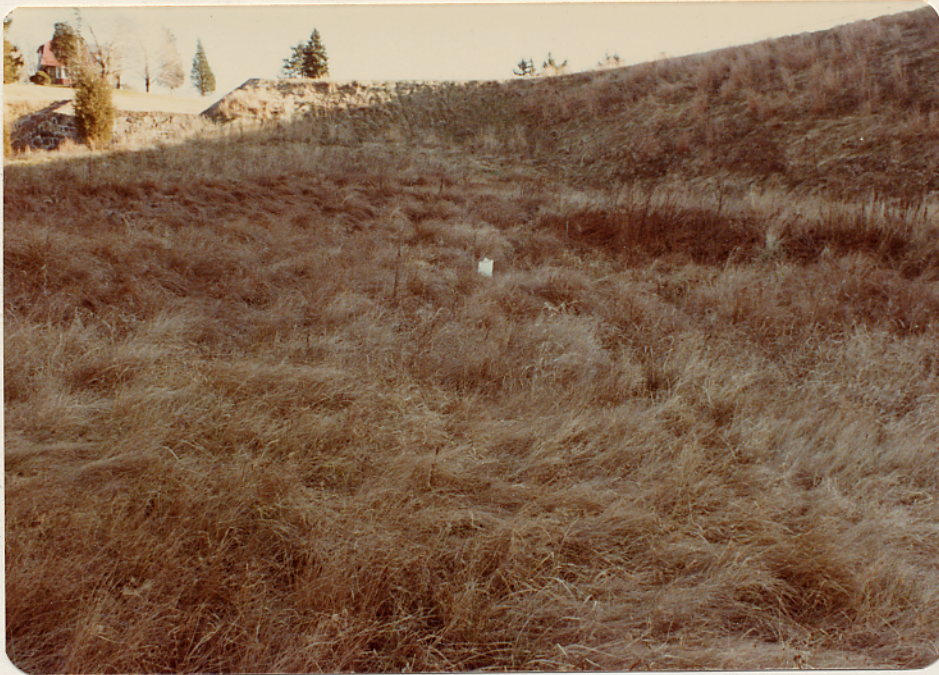
Downstream Slope - A view of the downstream slope in Photo 7 shows it to be covered with a heavy growth of grass, as is the berm along the toe of the slope also seen in Photo 7. A gentle hump was observed in the berm near the center of the dam. Several small areas of minor erosion a few inches deep were observed beneath the grass on the slope. Minor trespassing on the downstream slope was observed.

Two wet zones were observed near the two ends of the dam immediately downstream of the berm as shown on the dam plan sheet in Appendix Section B. The zone near the left abutment was approximately 35 feet by 25 feet in area. The zone near the right abutment was approximately 45 feet by 25 feet in area and can be seen in Photos 7 and 8.

PHOTO 7 - Right downstream toe of slope in wet area.

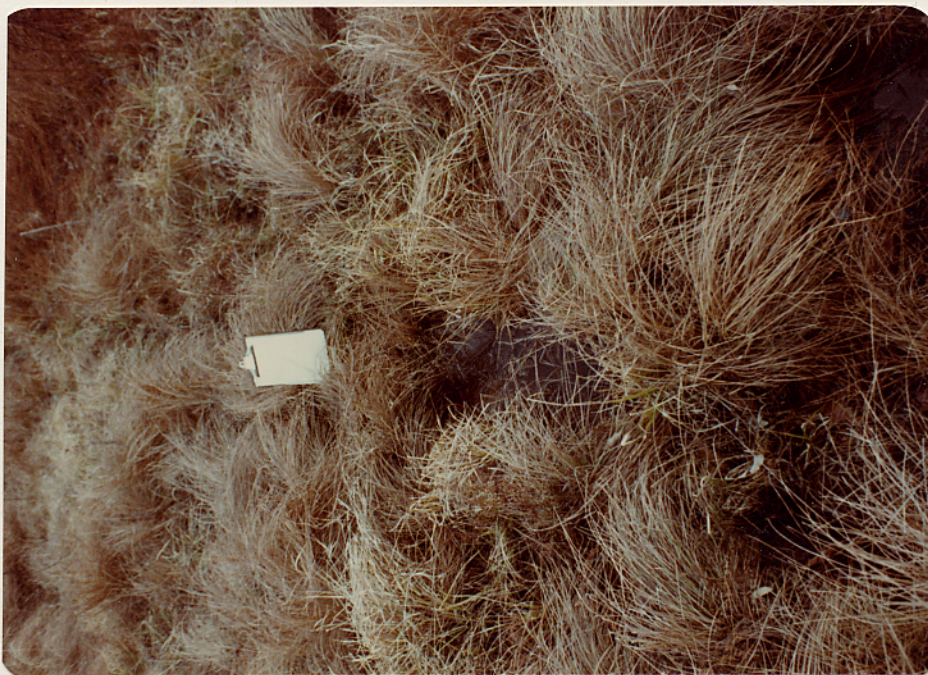
An August 1963 inspection of the dam indicated the existence of the two wet areas that were observed during this inspection. The right wet zone was reported to be 75 feet square and the left zone was reported to be about 20 feet square. In 1963, the caretaker reportedly recalled that the wet areas had been in existence for some years before 1963. Thus, it appears that the wet areas observed in the present inspection have been in existence since before 1963.

PHOTO 8 - Close-up of wet area at right downstream toe.

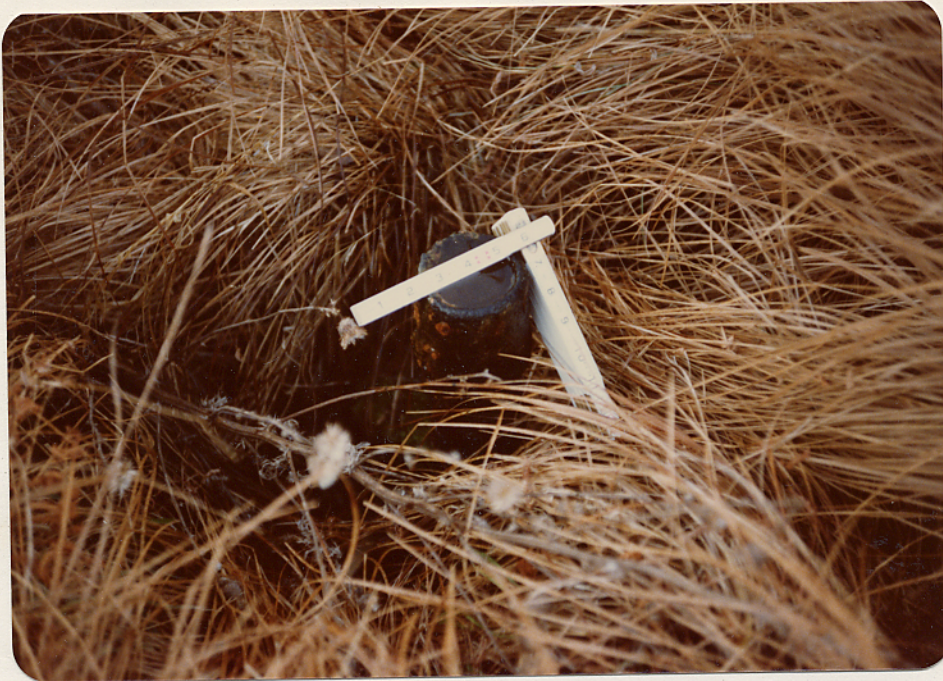
A standpipe observation well with an inside diameter of 2.5 inches was found in the wet zone at the right end of the dam (Photo 9). Clear water was observed flowing from the pipe at a rate of 0.04 gallons per minute as measured by timing the rise of water in the pipe after removing a few inches of water. A sounding of the pipe indicated it had a depth of 21 feet from the ground surface, which is the same depth given in a letter dated August 15, 1963. In that letter, a description of a small amount of clear water coming from the well seems to indicate no significant siltation of the well has occurred since 1963.

PHOTO 9 - Standpipe at right downstream toe of dam.

2. Inspection of the dam when the reservoir level is high. A measurement of the water flow from the standpipe observation well at the right downstream toe of the embankment should be made to determine if the volume of flow from the well is directly related to the water level in the reservoir. An evaluation of the significance of any flow increase noted should then be undertaken.

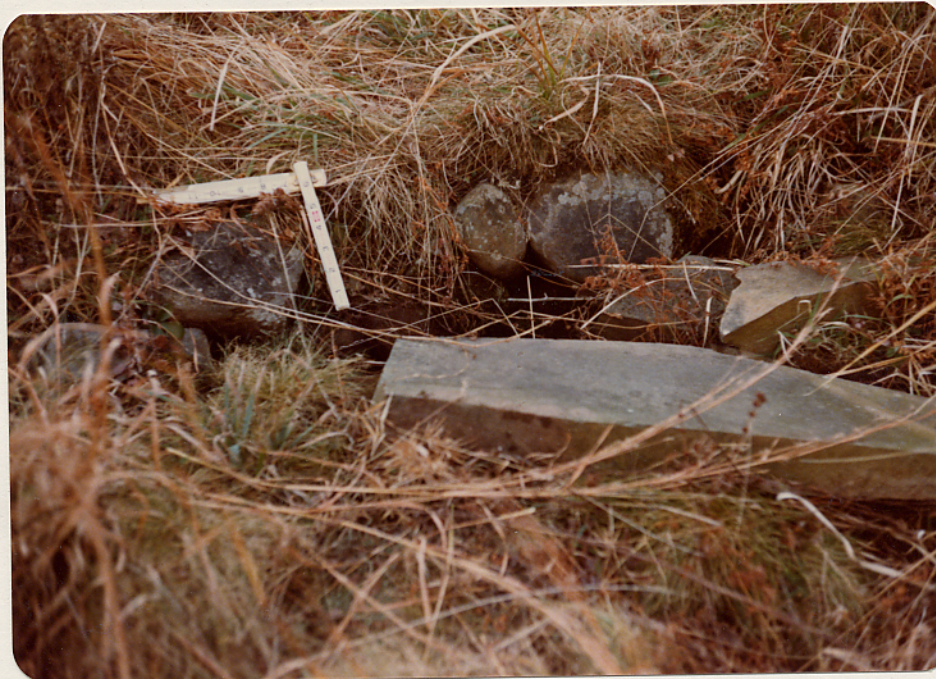
Stones were observed at the intersection of the downstream toe of the berm and the left abutment as shown in Photo 10. It is not known whether the observed stones are part of a toe drain. Also near the intersection of the downstream toe and the left abutment there is a vertical 24 inch diameter steel pipe sticking up about 1 foot above the ground surface and filled with soil to within a few feet from the top. The purpose of this pipe is not known.

PHOTO 10 - Partially buried stones at left toe of dam. Possible drain outlet.
